Replacing a Keel and Centerboard Trunk

New life for a Buzzards Bay 15-class sloop

by Maynard Bray

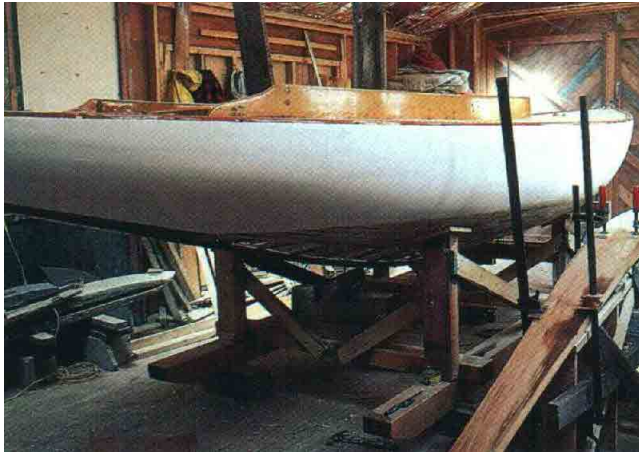
1 A wooden cradle supports MARIBEE's hull during the early stages and until the new keel is in place. In addition, two shores from the shop's overhead, temporarily screwed to floor timbers in the cockpit abaft the centerboard slot, help prevent the hull from distorting. Here, next to the boat, the new keel has been steam-bent to shape and clamped over a form. It was planed to a uniform 1 3/8" thickness beforehand and to the correct width as well—narrow where it will join the stem and transom, and about 10" wide in the middle where the centerboard trunk will land. The bending form consists of a sawhorse that has been padded and extended to duplicate the old keel's curved shape.

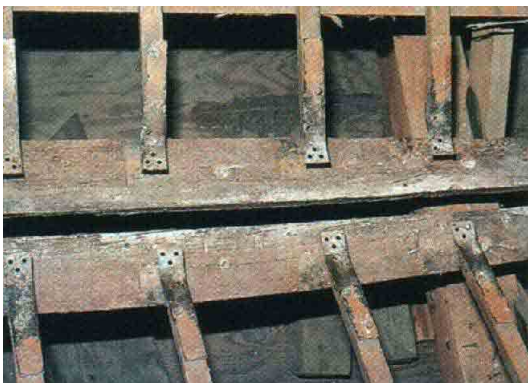
2 This view from the inside, taken just before the old keel was pulled out, shows the 138" centerboard slot and the brass straps that connect the frame ends to the keel.

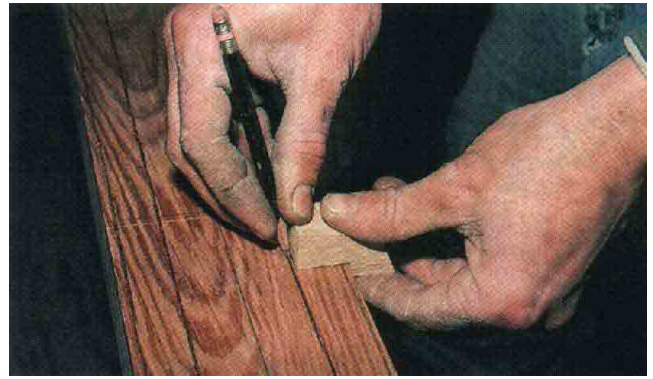
3 Continuous guidelines for cutting the rabbet are marked by running this stepped block of wood and a pencil along the new keel's edges, as Bob Williams is doing here. He'll also mark a line on both edges of the keel about an inch down from the top, to be used in fine-tuning the rabbet after the new keel has been fastened to the hull.

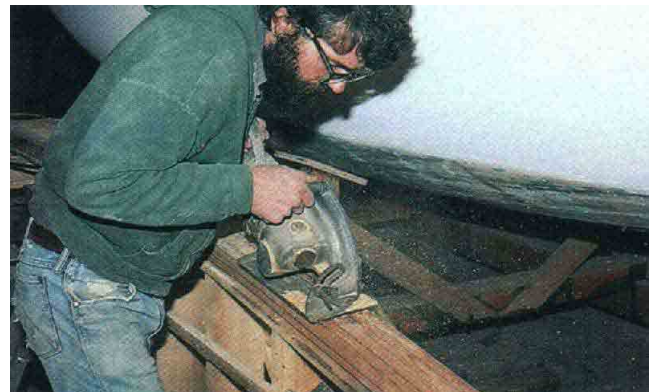
4 Guided by the lines marked on the keel's upper surface in the previous step, Bob begins to saw out the rabbet by cutting a little outside of the line and to a depth that is sufficiently shallow for later finishing with a hand rabbet plane. Notice that this work takes place while the bending jig still supports the new keel. (Since there is no curve in the forward and after thirds of the keel, these ends are allowed to overhang the bending form.)

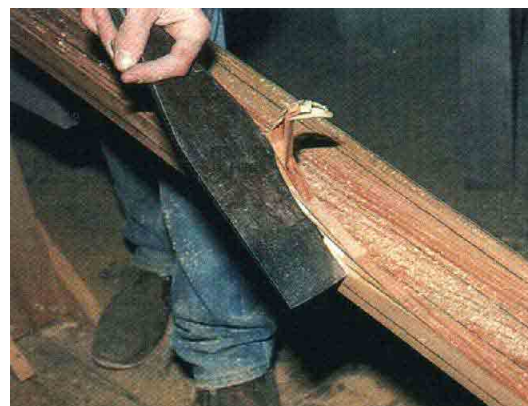
5 A big, heavy, and very sharp slick peels away waste wood and makes quick work of paring down the roughed-out rabbet.

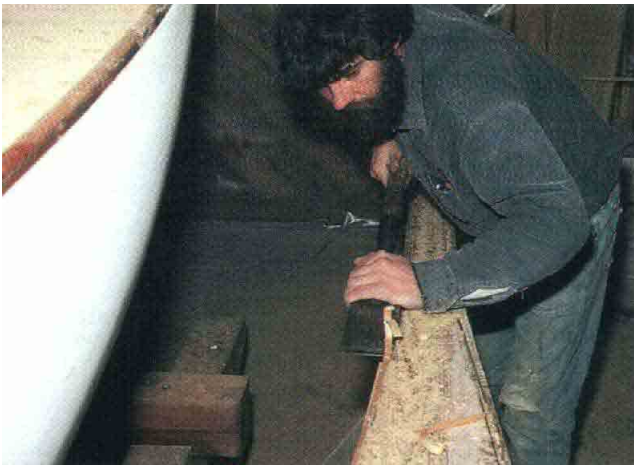
6 Rough-cutting of the rabbet continues. The tapering keel width shows here at the forward end of the new timber.

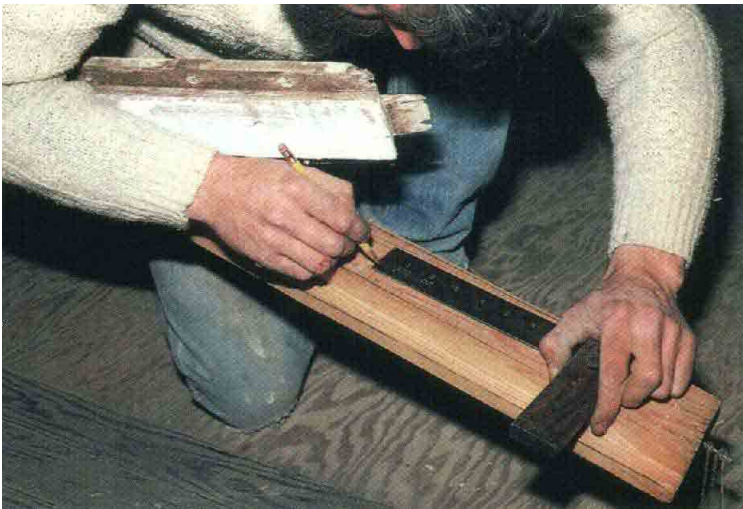
7 At the new keel's after end, Bob marks for a cut that will duplicate the old...

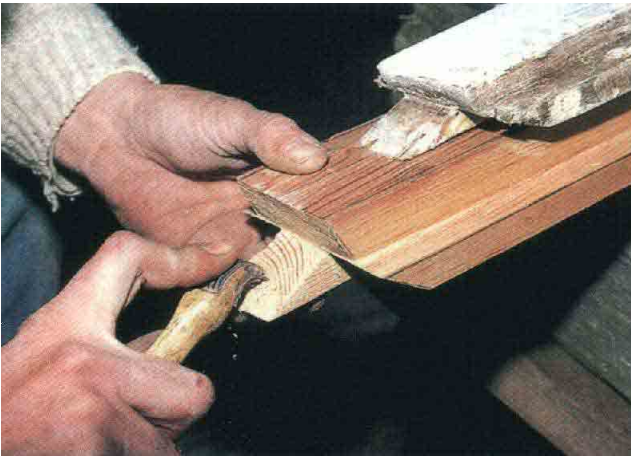
8 ...and cleans up his saw marks with a scraper so that this surface can land in close contact with the inner face of the transom. The new keel's forward end is similarly cut to marry with the stem, to which it will be bolted.

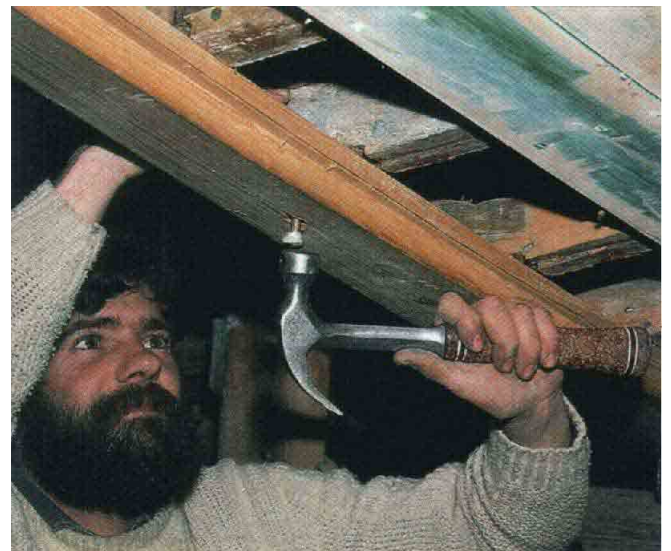
10 New bronze carriage bolts, driven upward, fasten the keel firmly to each floor timber. A ring of caulking cotton under each bolt head will keep out the water.

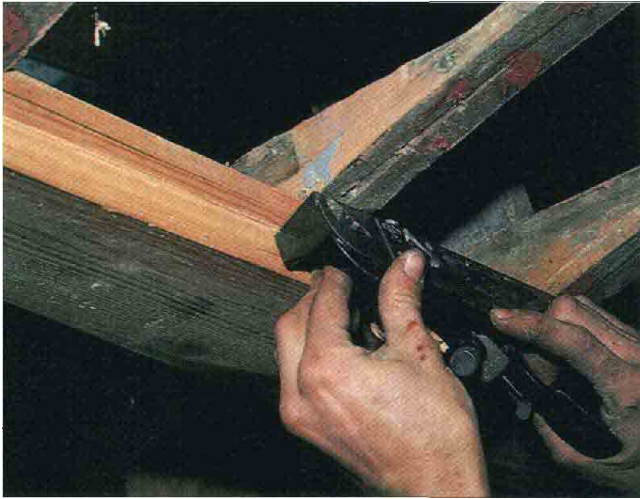
11 After the new keel is permanently attached, comes the tedious task of planing the rabbets (using the frame heels and floor timbers as guides) so that the garboard planks will lie fair against them. Because reuse of the old garboards is planned, the new keel has been given slightly shallower rabbets, and therefore more exposed width across its underside, than the old one (see Figure 1).

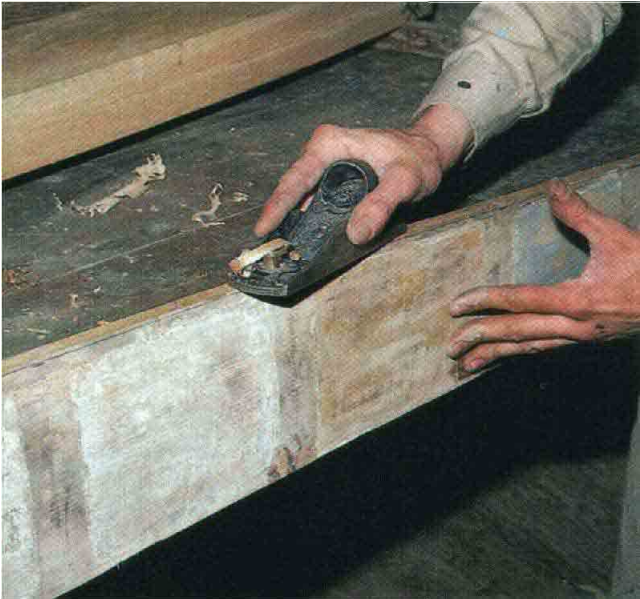
12 Here, the edge of a garboard that will lie against the new keel has been marked with the new and slightly narrower plank widths and is being planed down to those lines.

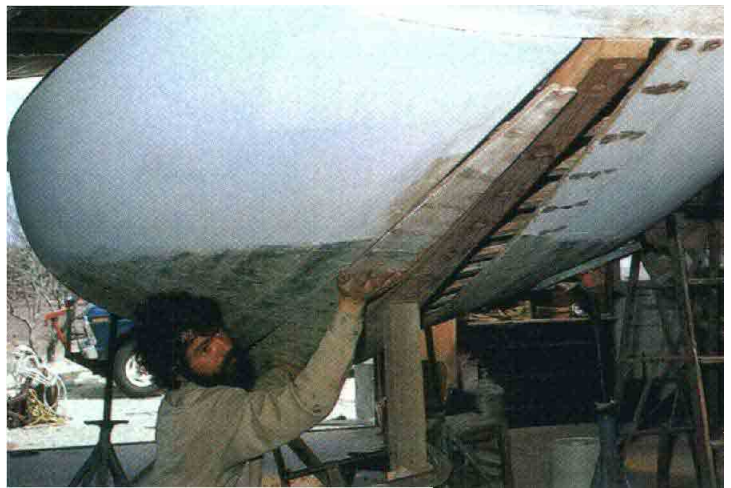
13 Because, for this repair, the garboard is the "shutter" plank, some cut-and-try fitting is required. Note that the boat's cradle has been removed and that the hull is now supported by a pair of braced posts under the keel and held upright by jackstands.

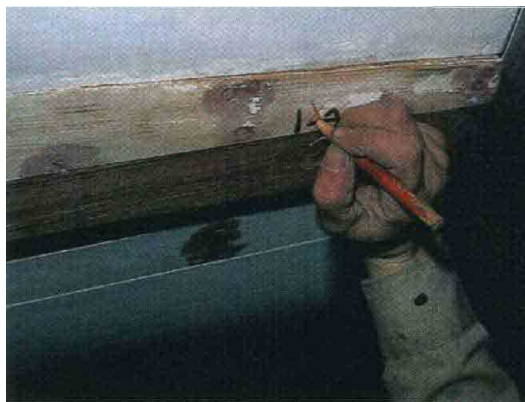
14 Accurately fitting a shutter plank is a slow and careful process that consists of marking the areas where the plank binds...

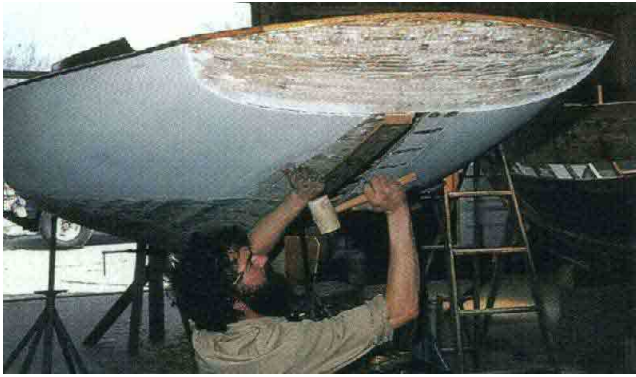
15 ...then taking off a few shavings, and trying it again until there's a good fit, both along the plank's edges and at each end. Notice that the existing screw holes have been filled (with epoxy and microballoons) before the plank is driven home for the final time.

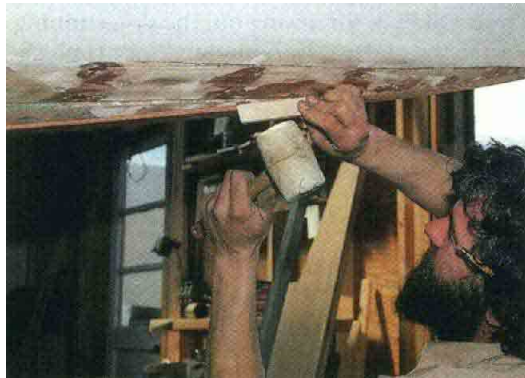
16 Since the garboard plank comes to a sharp and delicate point forward, a softwood block helps distribute the taps of the mallet and protect the cedar plank from damage.

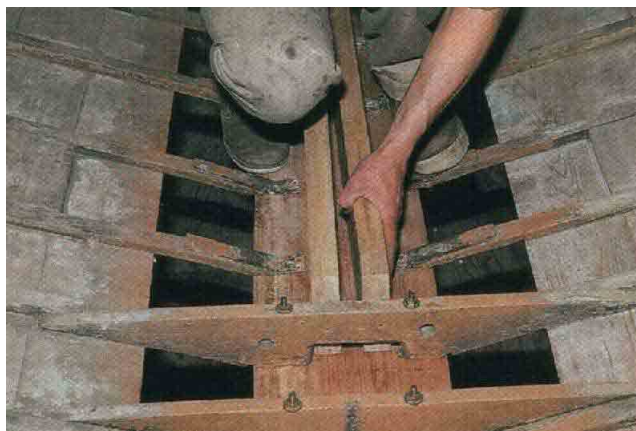
17 The 1 3/8" bedlogs of oak will be scribed to fit the curve of the keel's top surface. Virtually all Herreshoff-built sailboats having centerboard trunks also have floor timbers crossing the keel in close proximity—

one immediately abaft the trunk, and another immediately forward. As the trunk starts leaking with age (as centerboard trunks invariably do), those two floor timbers, as installed, prevent all-around access, so one of the solutions has been to chisel and saw an opening through the interfering floor timber between its pair of keelbolts, as shown in this photograph. That way, the trunk can be caulked from inside the boat where its endposts penetrate the slot in the keel. (This new keel's slot has yet to be cut.)

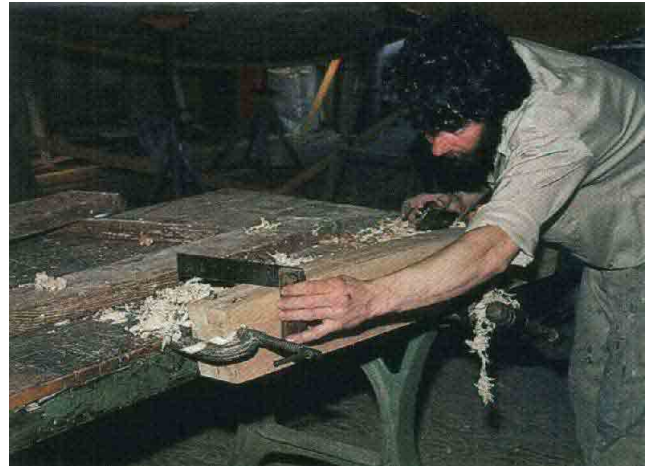
18 Here the matched pair of bedlogs is being planed square and to the scribed line.

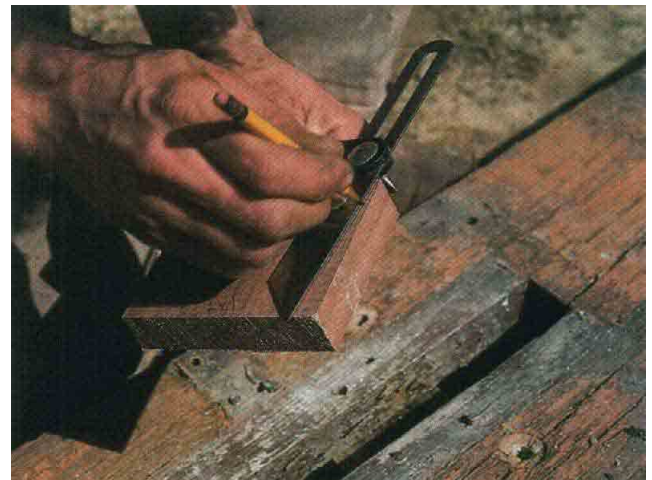
19 Part of the information obtained from the old keel is the bevel at the ends of the centerboard slot, made necessary because of the slant of the endposts. Here, the bevel that has been taken is recorded on a piece of scrap wood so it can be accurately transferred to the new keel.
