Restoring the S-Boat Mischief, 2nd Episode

This is the second episode of the Herreshoff S-boat *Mischief's* restoration at Brooklin Boat Yard. *Mischief* had to be rolled underneath *Isobel* at this stage to give other projects floor space. Her cabin here is complete, but let's look at earlier photos to see how the work was done.

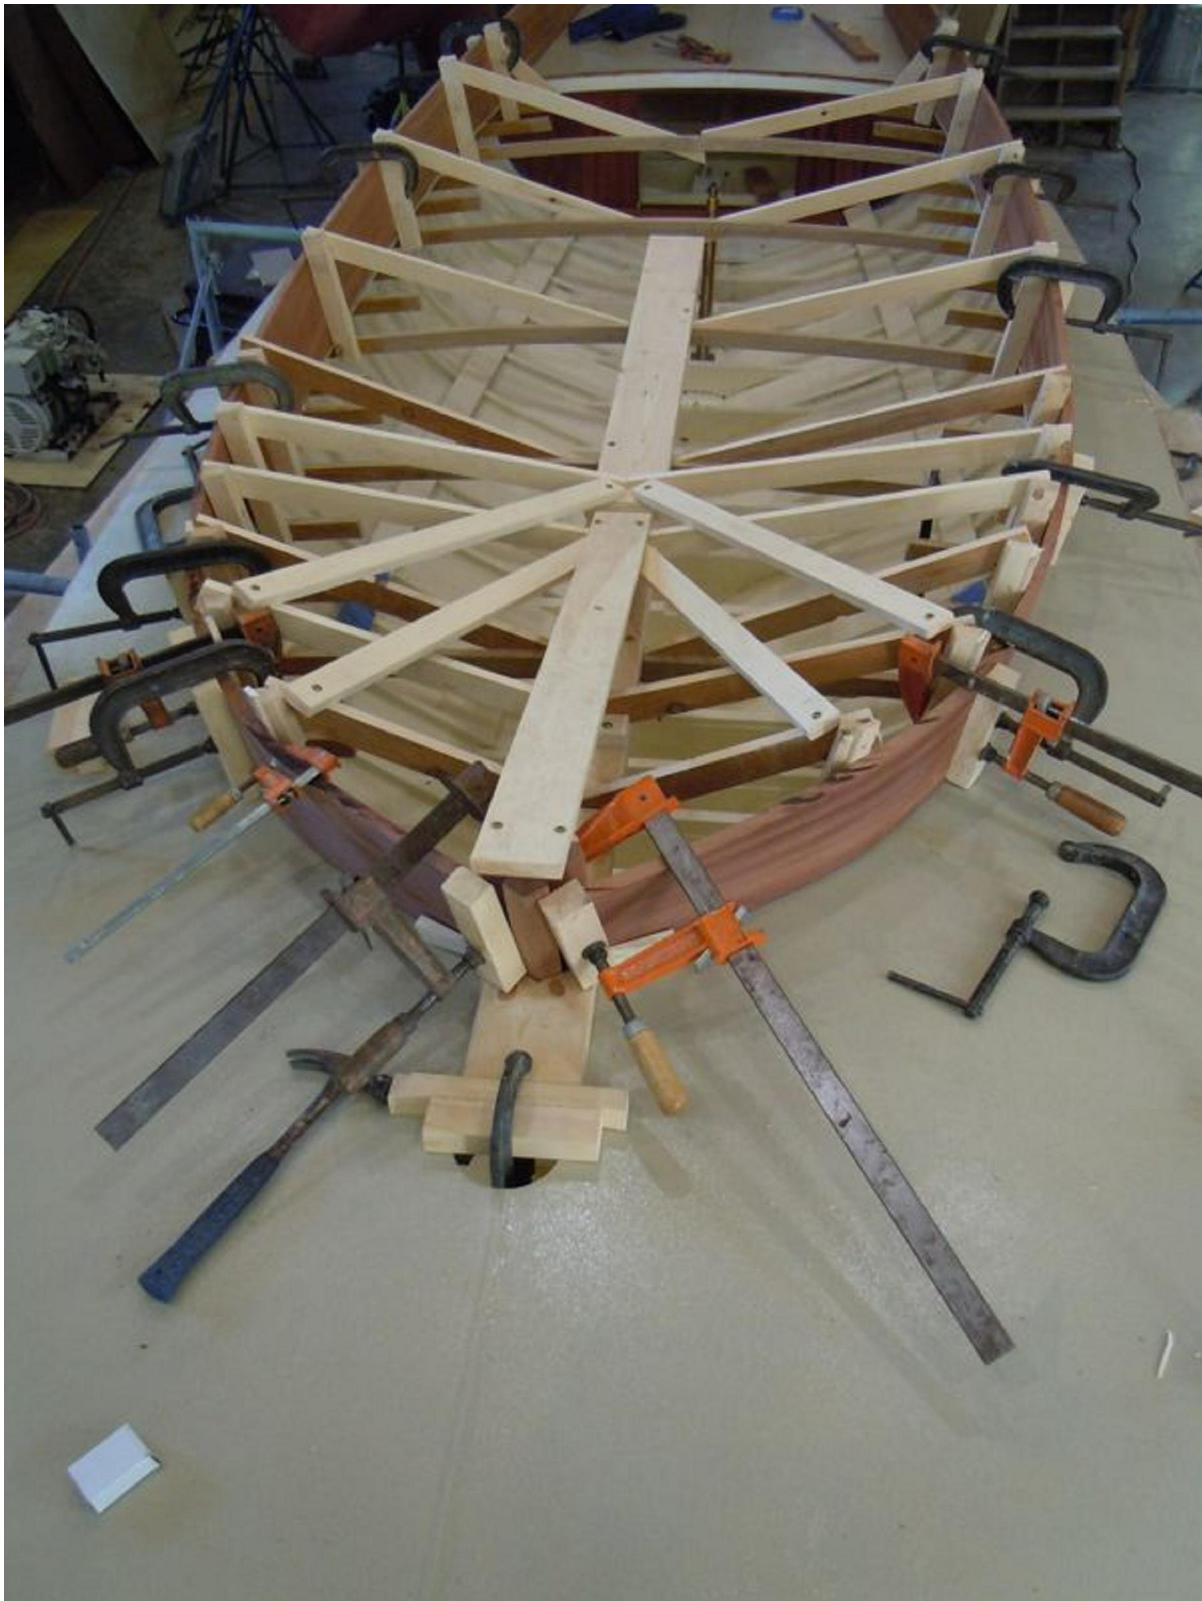
The one-piece mahogany cabin sides, which extend aft to include the coamings, are first roughly cut to shape, then steamed and bent around these ruggedly braced and correctly located uprights. Every third deck beam runs temporarily side-to-side to give the bracing a temporary foundation.

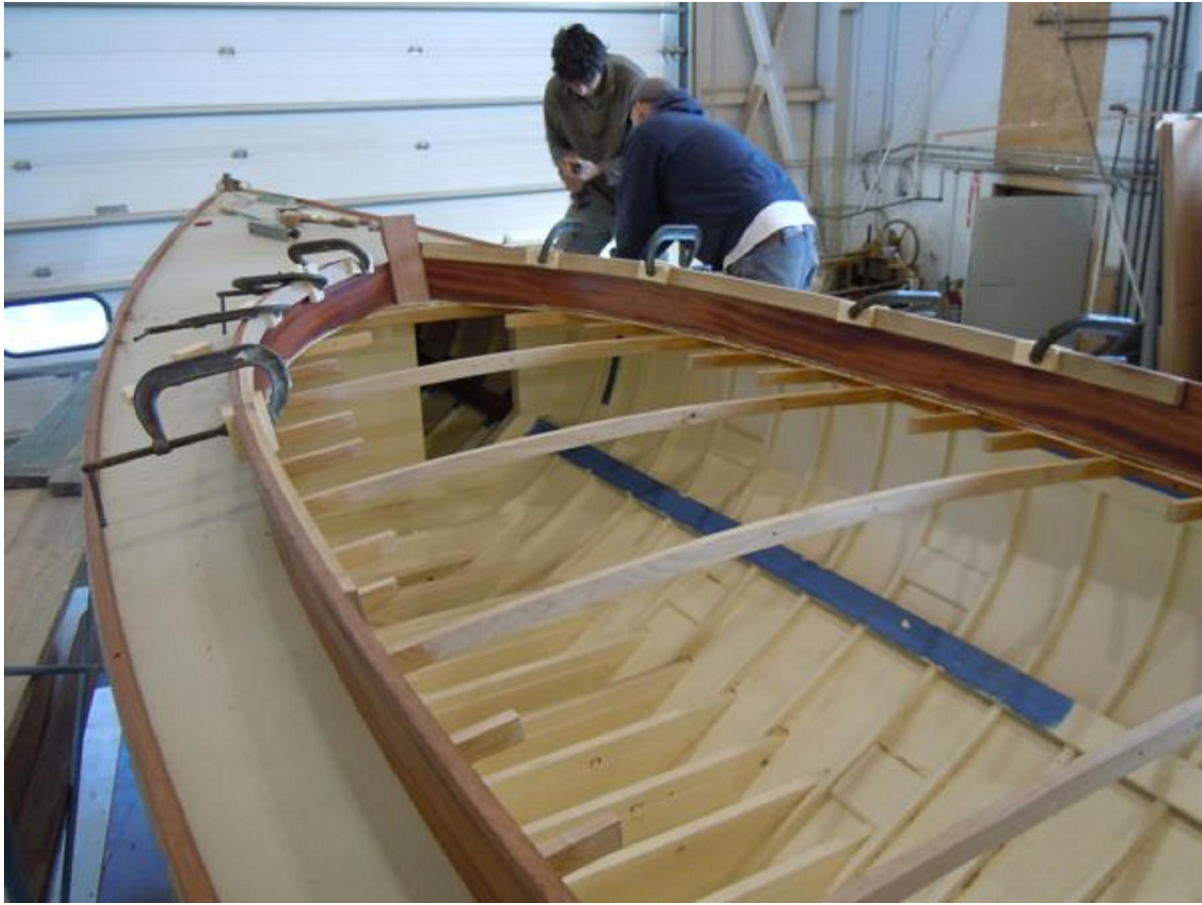
The cabin roof beams will notch and fasten into these oak headers that, like the cabin sides, have been steamed and bent into place. They will be fitted, bedded, fastened, and trimmed before notching.

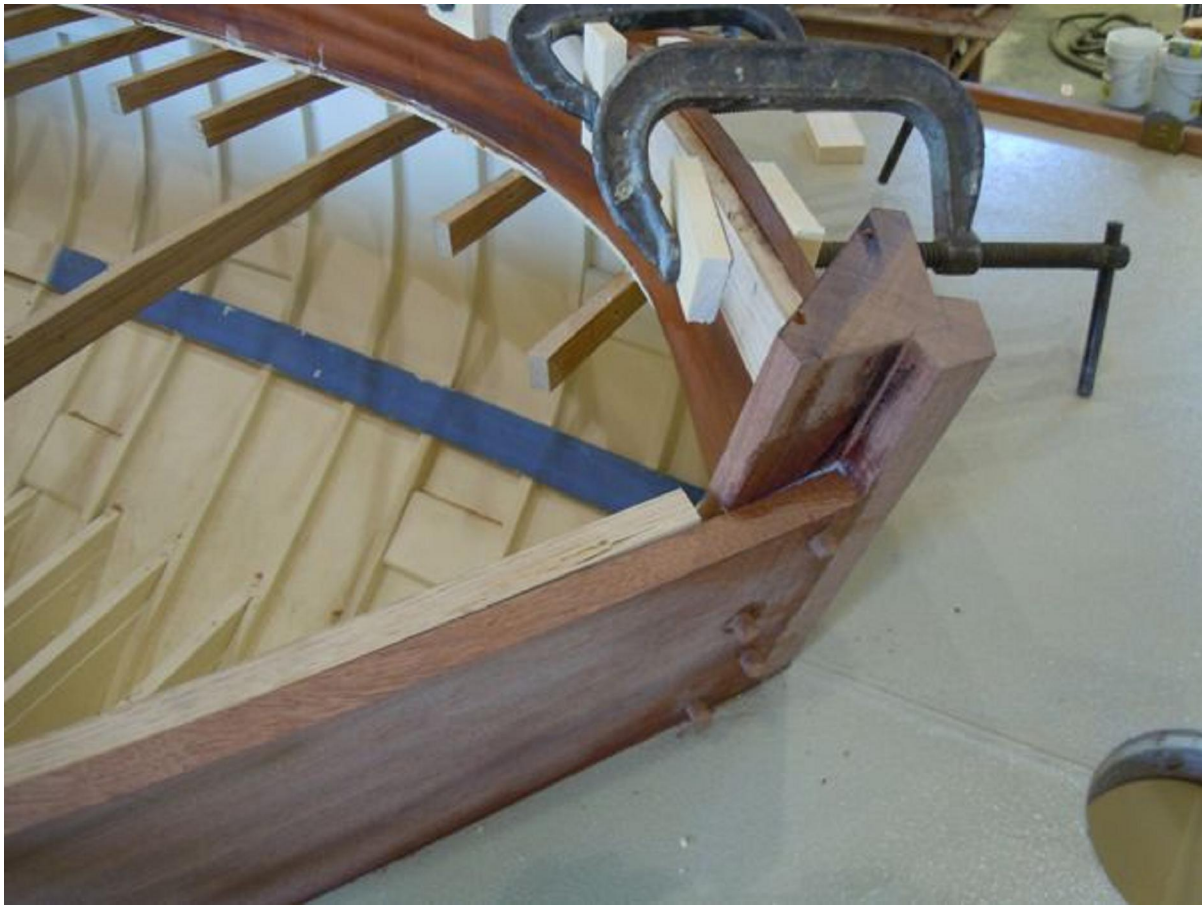
At the cabin's pointed forward end, a rabbeted centerline post ties together the cabin sides.

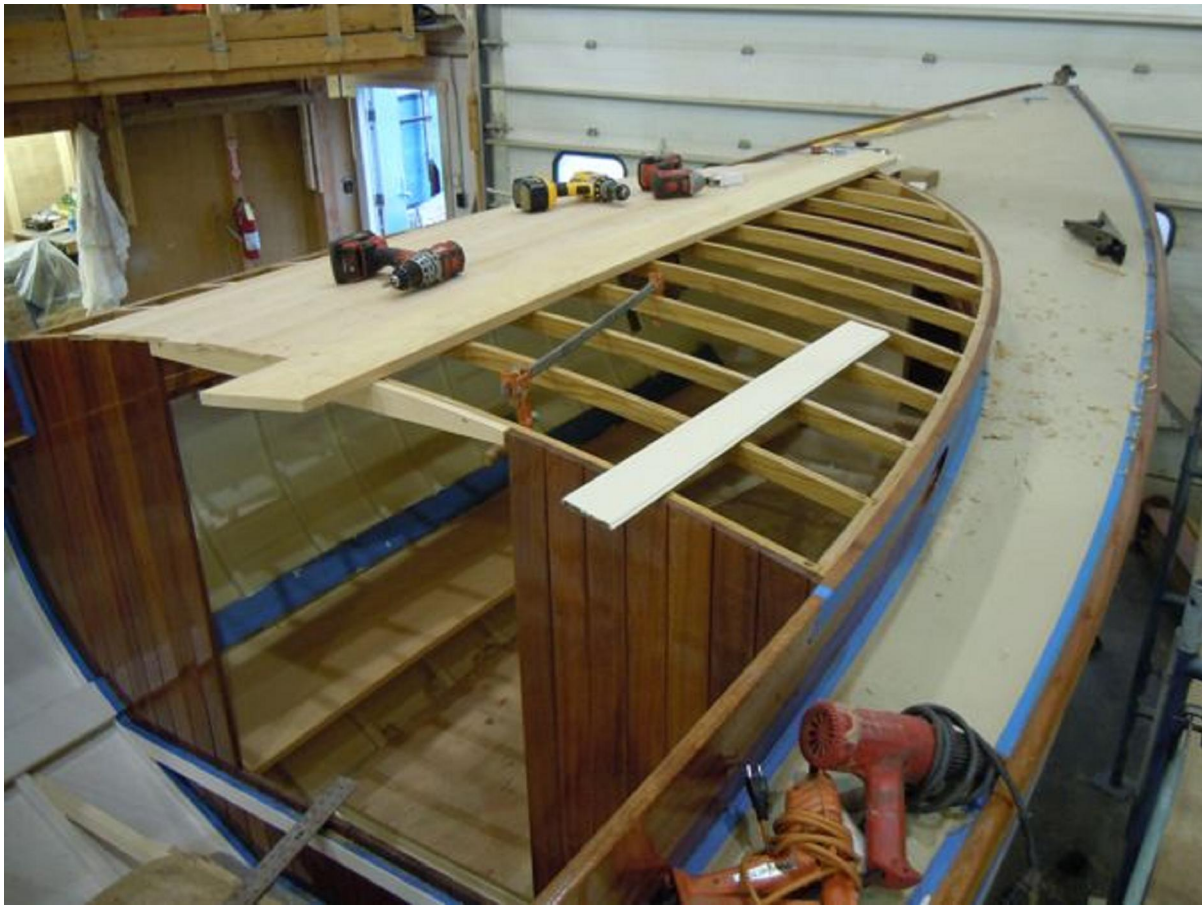
Beams are now notched into the header and fastened, and the pine tongue-and-groove roof planks are being laid to look just as they did when *Mischief* was new.

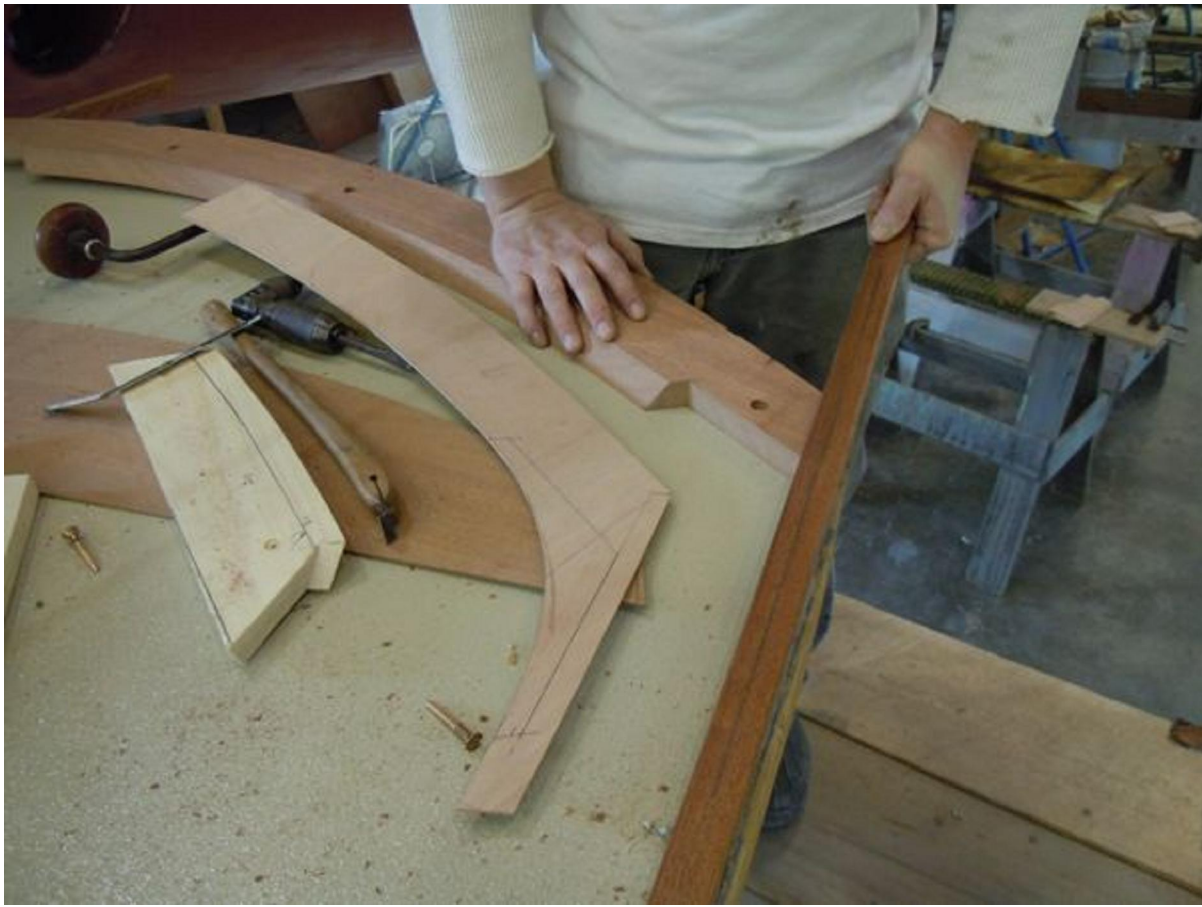
The fit gets checked and fine-tuned before the final cut is made, by springing the toerail up over the taffrail where it also can be accurately marked. The assembly, including the transitional knee, was first laid out on a plywood pattern.

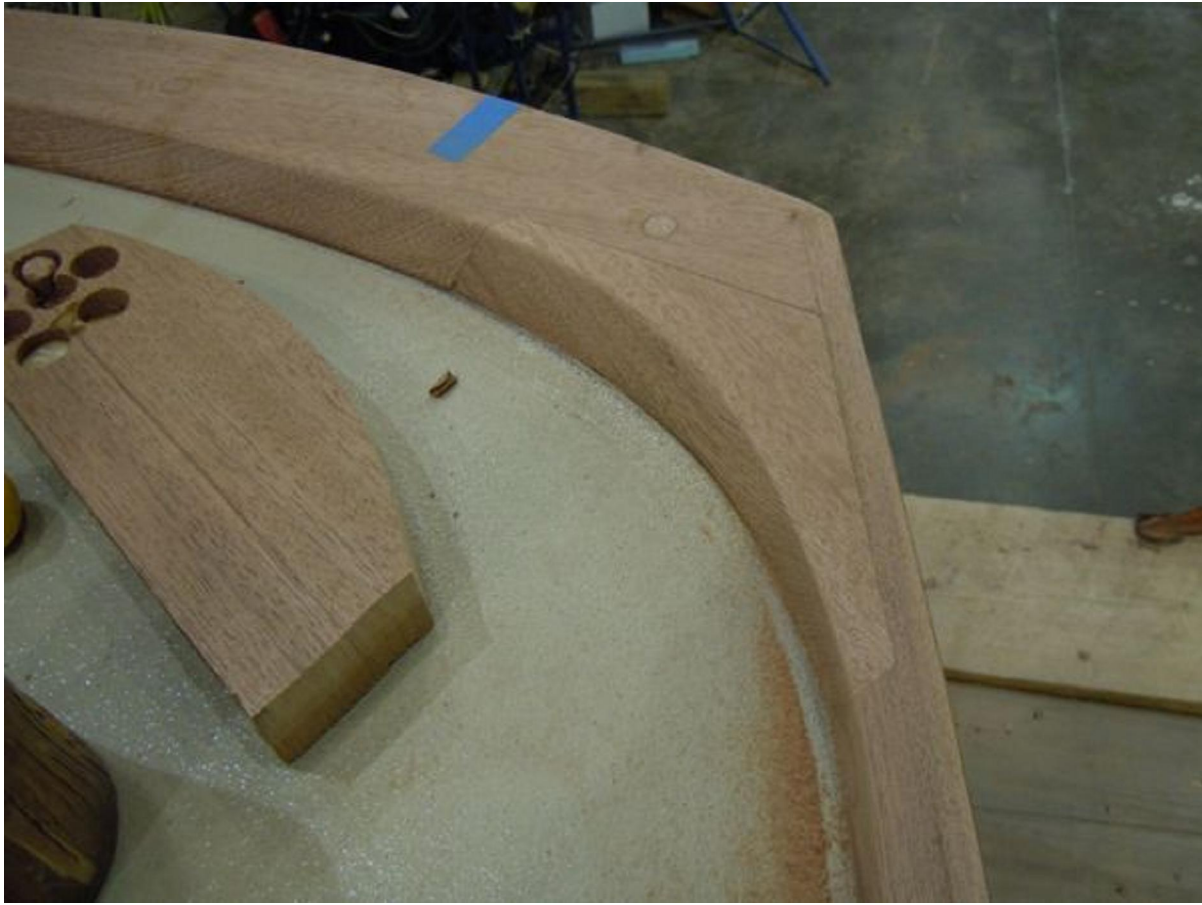
Wood-to-wood fits are important elements of good craftsmanship, but the gradually-changing bevel of this assembly's inboard edge as it flows from near the near-vertical toerail to the raking taffrail is vital as well—to overall good looks.

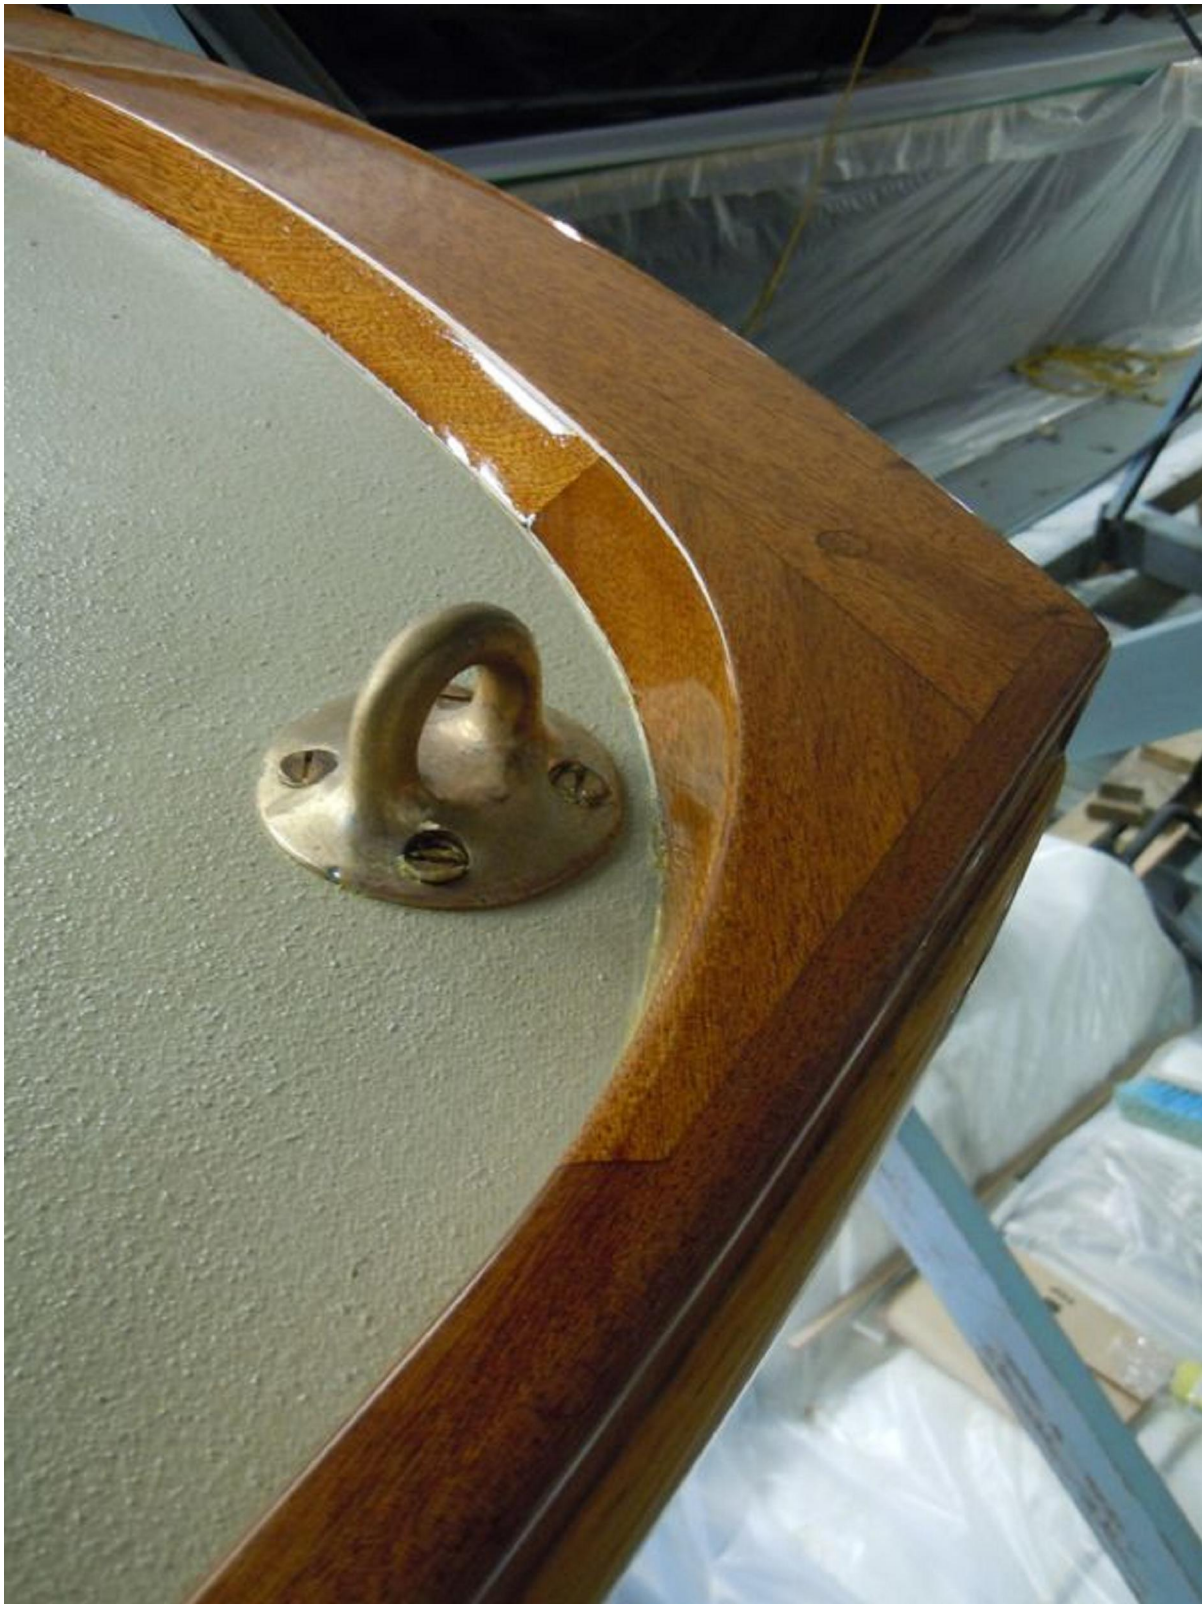
With a full buildup of varnish over these carefully-shaped pieces, their beauty really shows. There's harmony between the rake of *Mischief's* transom, the crown of her deck, and the flare of her topsides.

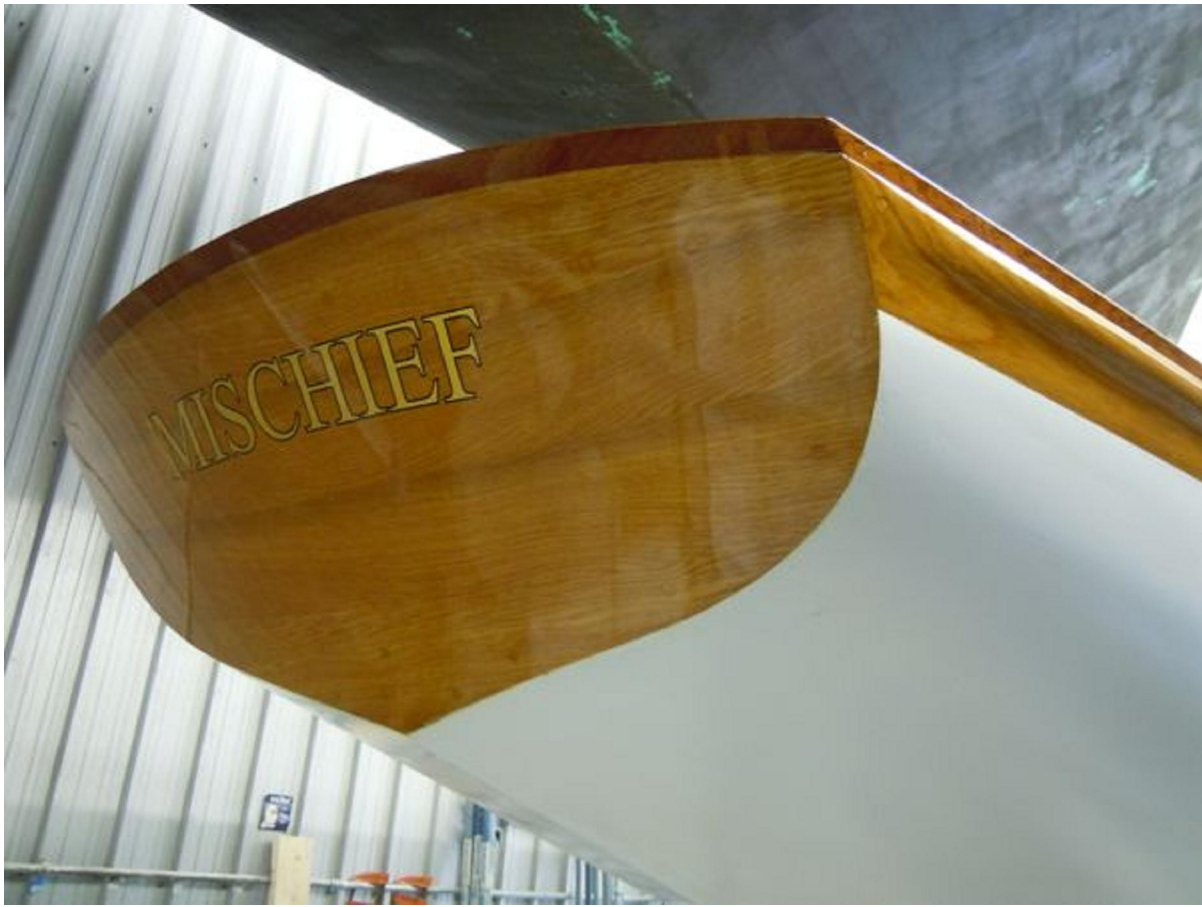
Outside the boat, the signature Herreshoff “bulge” (which provides needed extra thickness to the sheerstrake’s upper edge) gradually and completely dies out at the corner of the transom. And how about that lovely understated reversing curve where the paint and varnish meet!
